Inspection Report

Minerals Regulatory Program

Mine Name: Eagle Canyon
Operator Name: Georgia Pacific

Permit number: M0150050
Inspection Date: July 1 and July 29, 2008
Times: 11:30 AM to 1:00 PM on July 1; 10:30-11:40 AM on July 29

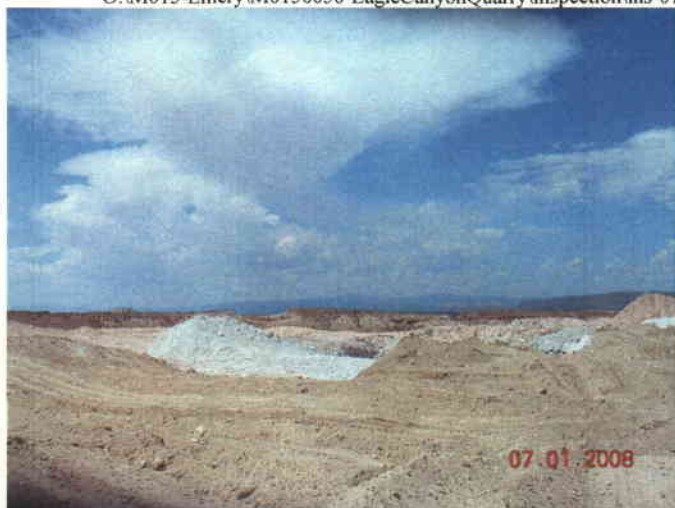
To the left of center in Photo 1 is a gypsum stockpile which by the inspection on July 29 had been almost completely buried. Other areas that were basically regraded are shown in Photos 2 and 3.

Photo 1. Just to the left of center in this photo is a gypsum stockpile that has now been mostly buried.

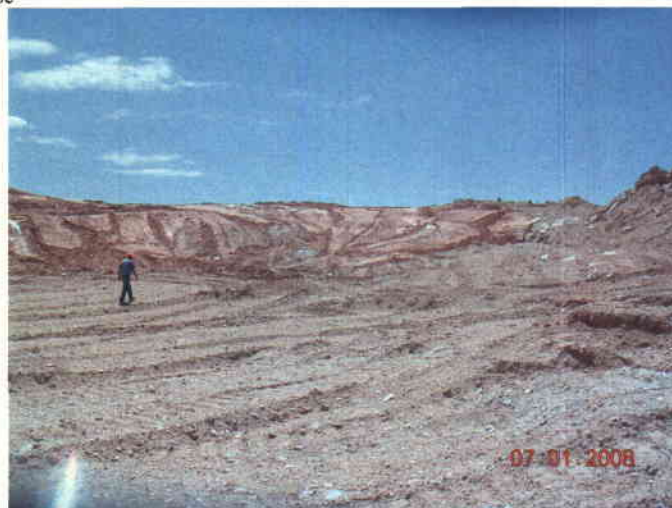
Photo 2. This photo and photo 3 show areas that have been mostly or completely regraded.

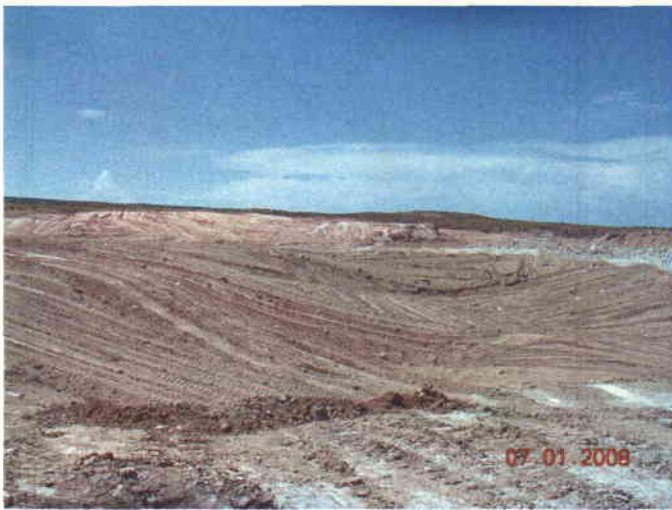
The mine consisted of several pits, and while the operator has been using available material to fill them, it is impossible to fill them completely. We discussed whether the pits should be free draining and decided that this was not necessary. The area receives limited precipitation, so it is unlikely the pits would ever have standing water for more than a few days except perhaps in the winter when there is less evaporation. There is almost no chance at all that these would overflow.

Photo 3. Water would pond in this area.

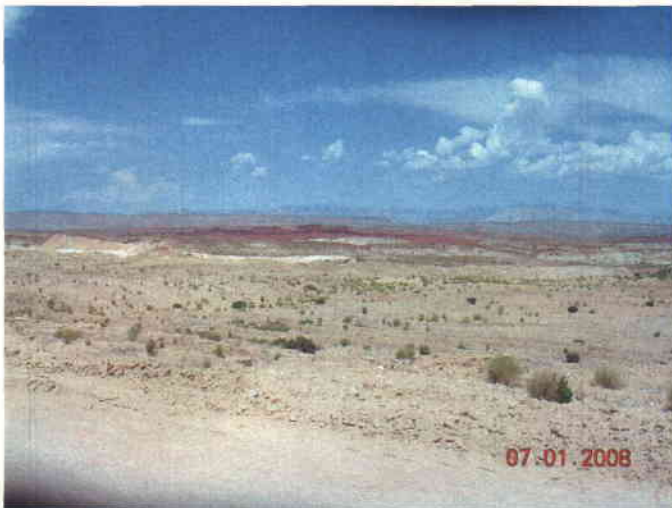
There are some areas near the entrance that were regraded in about 2000 and were not seeded (Photo 4). These areas have moderately good cover from native species, and although there are windrows of soil perpendicular to the contour, we decided it would be best to leave these areas as they are. They are flat enough that, in spite of the soil windrows, I have never seen any signs of accelerated erosion.

Photo 4. This is an area near the entrance that was regraded in about 2000. While the vegetation is not lush, it consists of native species and is not bad considering the difficulty of establishing vegetation in this area.
